TECHNICAL REPORT S-71-II

**COMPARISON OF PERFORMANCE OF  
EXPERIMENTAL MEMBRANES, NONSKID  
COMPOUNDS, ADHESIVES, AND EARTH  
ANCHORS WITH REGARD TO C-130 AIRCRAFT  
OPERATIONAL REQUIREMENTS**

**T. W. Voller**

August 1971

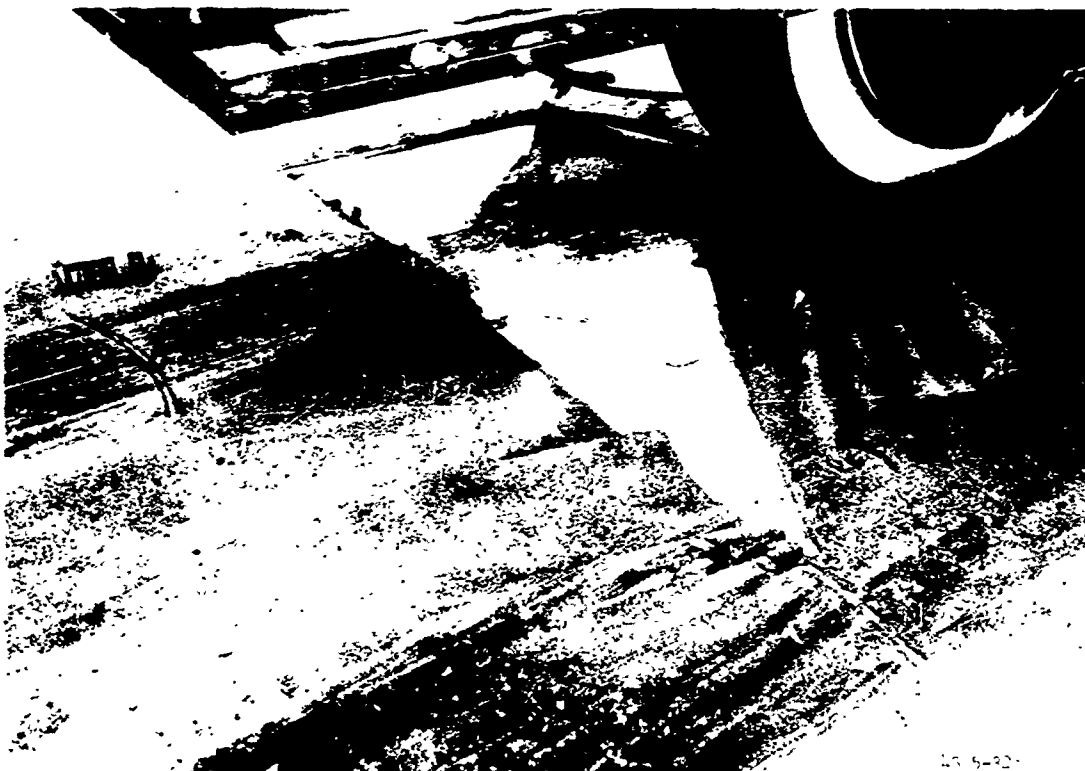
- a. Dry-skid tests. Failure occurred in the XW27 during two of six dry-skid tests. The first occurred during the second skid test and is shown in photograph 18. It was not considered a complete failure, since only the top ply of fabric failed. However, it did weaken the waterproofing capabilities of the membrane surfacing and would necessitate immediate repair of the surfacing under field conditions. The second failure occurred during the sixth skid test and is shown in photograph 19. It occurred at the beginning of the skid test and was 5.5 ft wide and 2.25 ft long. It was caused by the abrasive action of the C-130 wheel on the top surface of the membrane and the abrasion of the asphalt pavement on the underside of the surfacing. The average drag forces during the dry-skid tests on the XW27 were less than those on the WX18. The neoprene coating was more readily removed from the XW27 than from the WX18 and T17. The XW27 lay flatter than any of the other membranes and had fewer fabrication wrinkles. This contributed to its partial success in withstanding the loads of the skidding C-130 wheel.

Photograph 18. Top-ply failure of XW27 experimental membrane surfacing resulting from dry-skid test 2 (asphalt pavement subgrade)

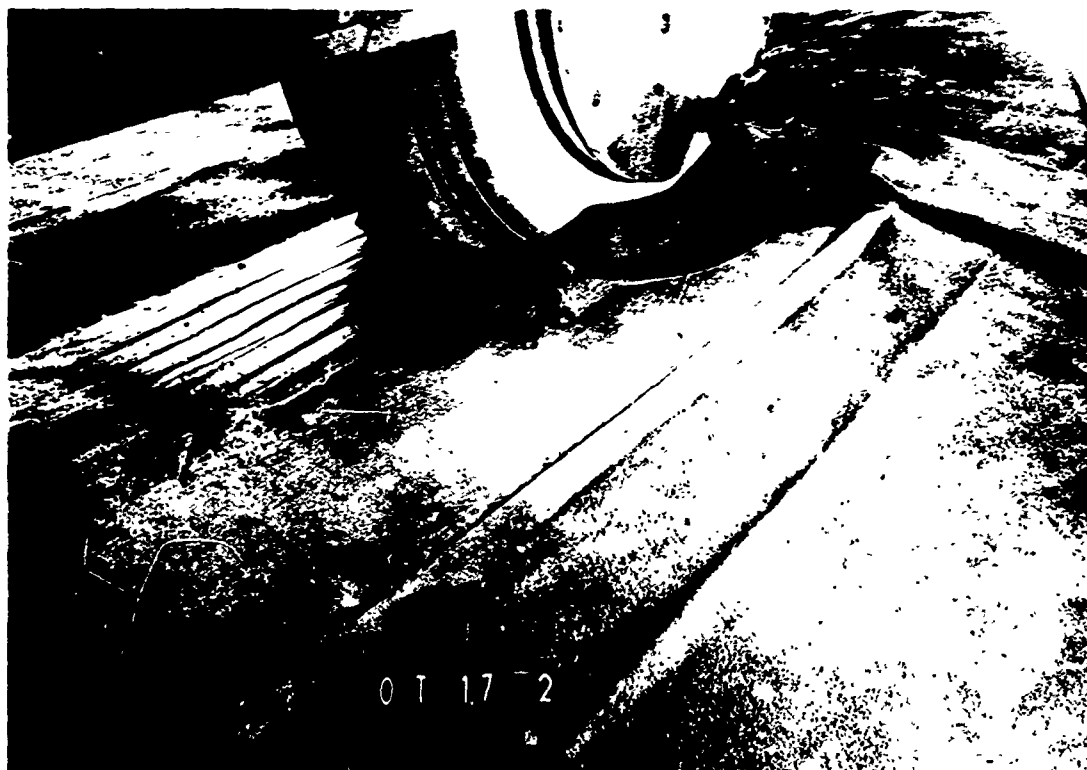
Photograph 20. Failure of T17 membrane resulting from dry-skid test 1  
(soil subgrade)

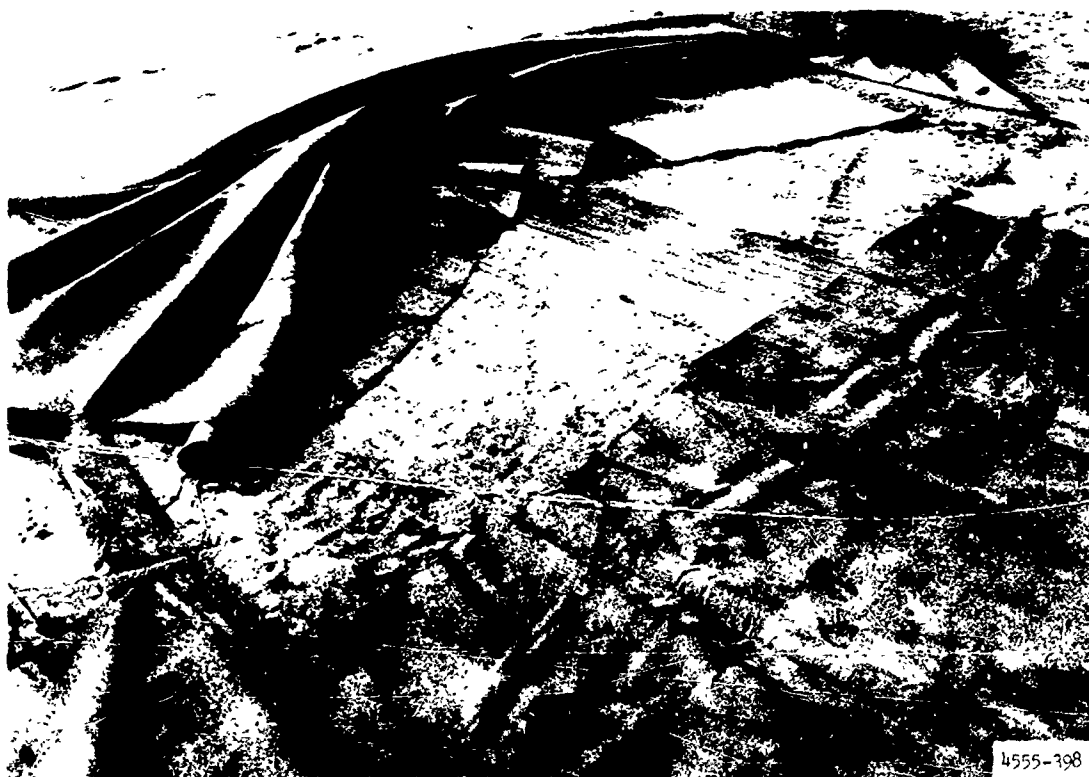
Photograph 30. Overall view showing neoprene coating peeled from nylon fabric of XW26 experimental membrane during dry-skid tests (soil subgrade)

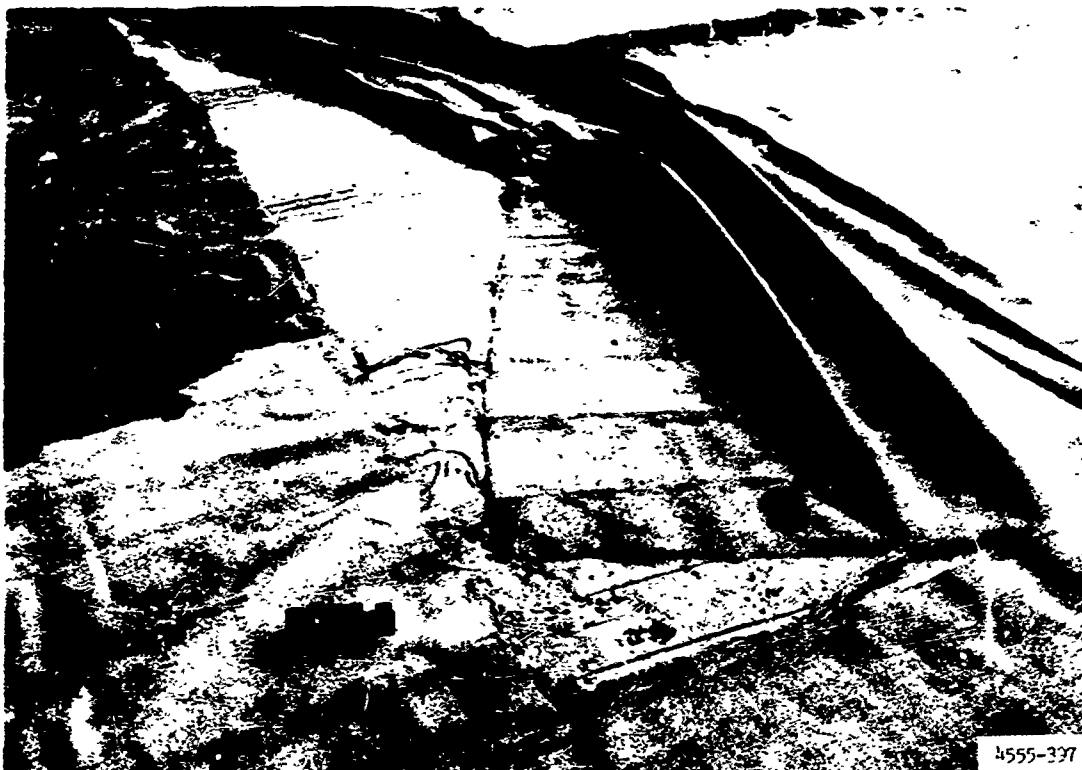
Photograph 33. Typical skid mark resulting from wet-skid tests on XW27 experimental membrane (soil subgrade)

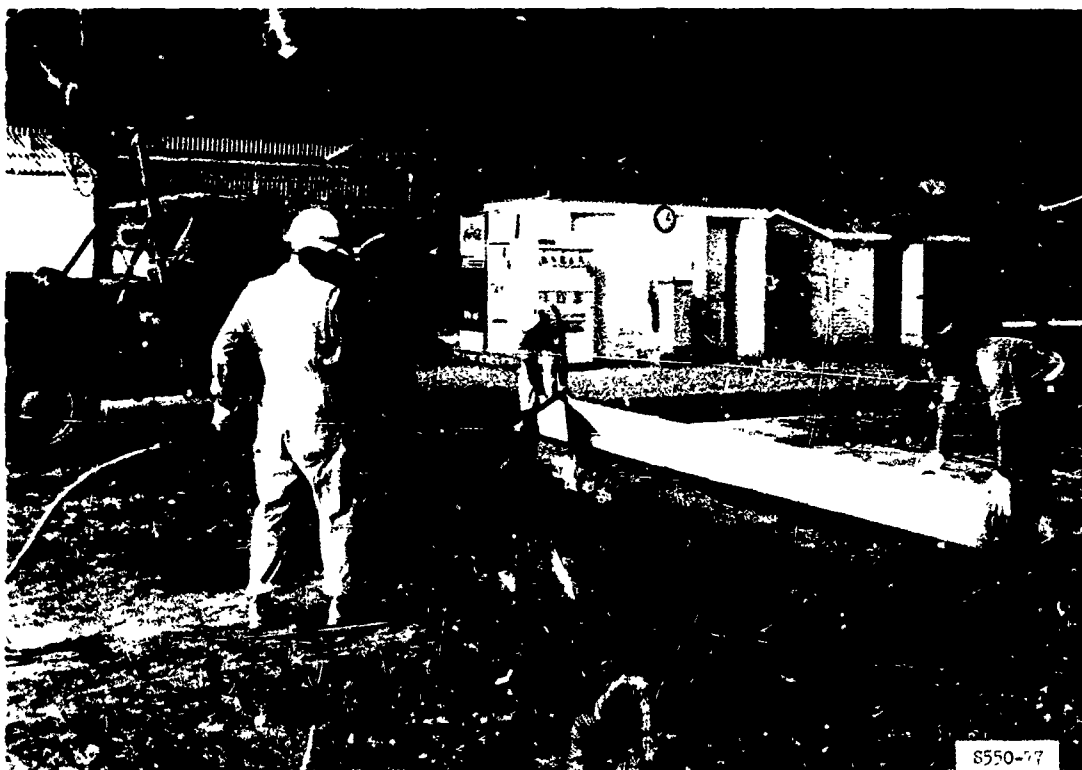
Photograph 34. Failure of XW27 experimental membrane resulting from wet-skid test 5 (soil subgrade)

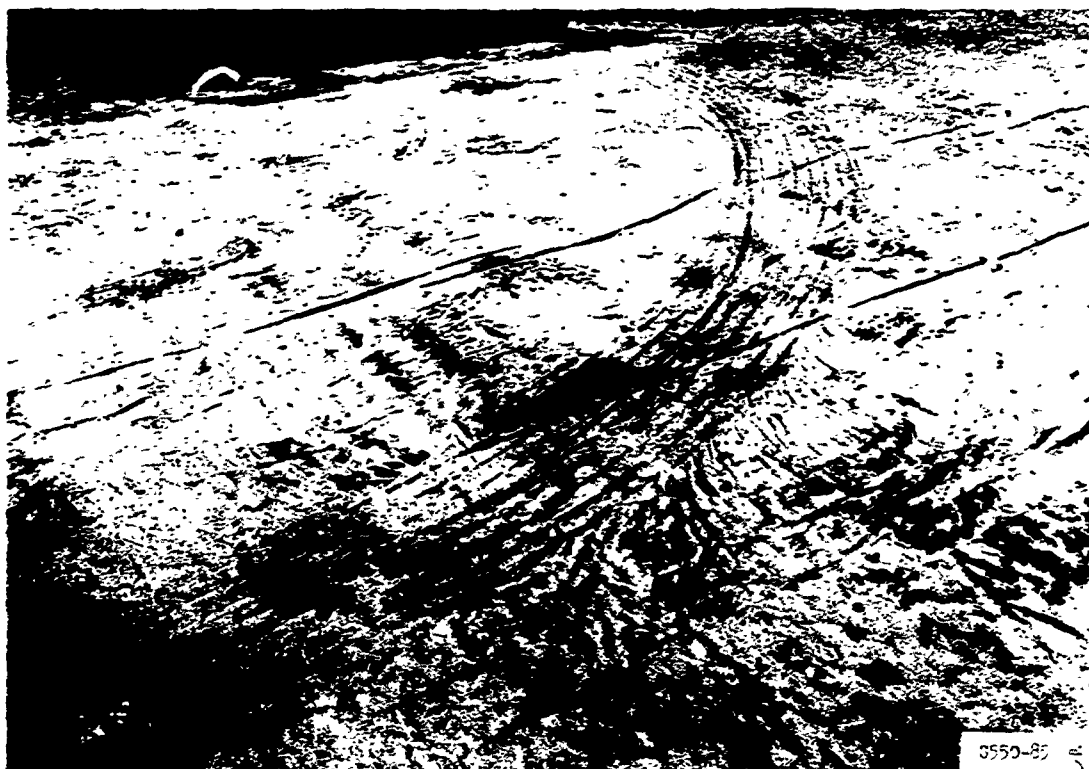
Photograph 39. Failure of 1-ply polypropylene resulting from first dry-skid test

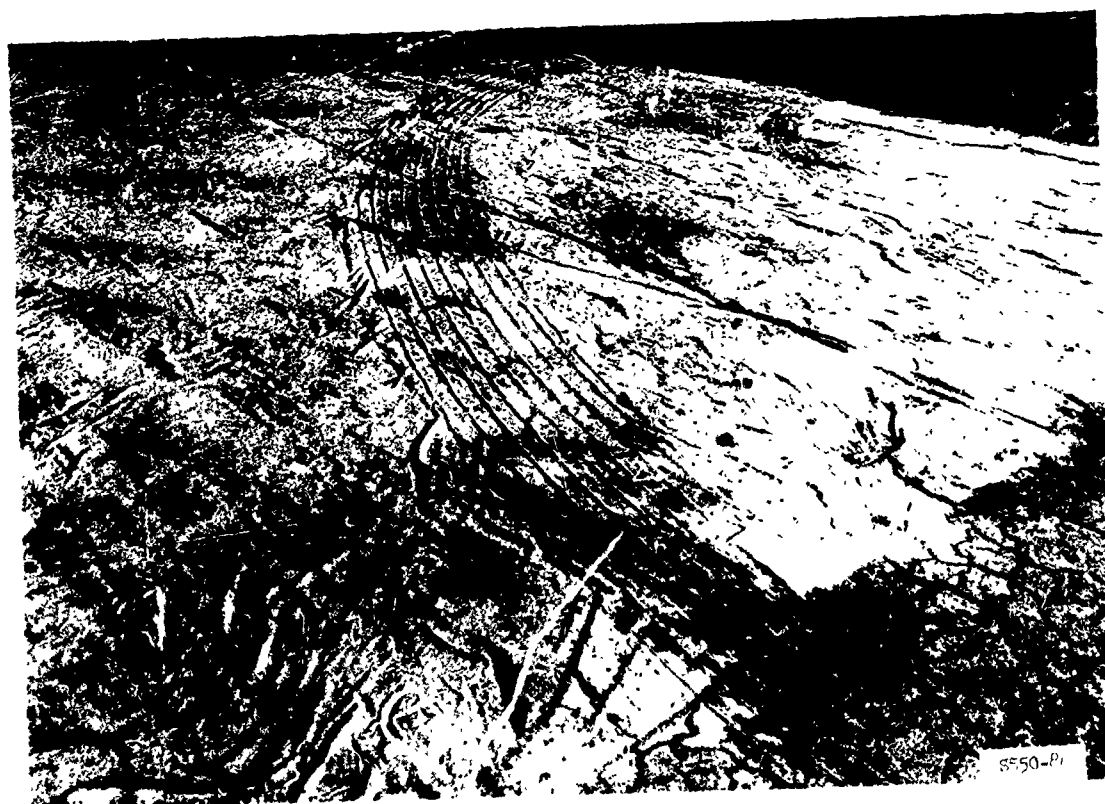
Photograph 42. Failure of 2-ply polypropylene resulting from dry-skid test 1

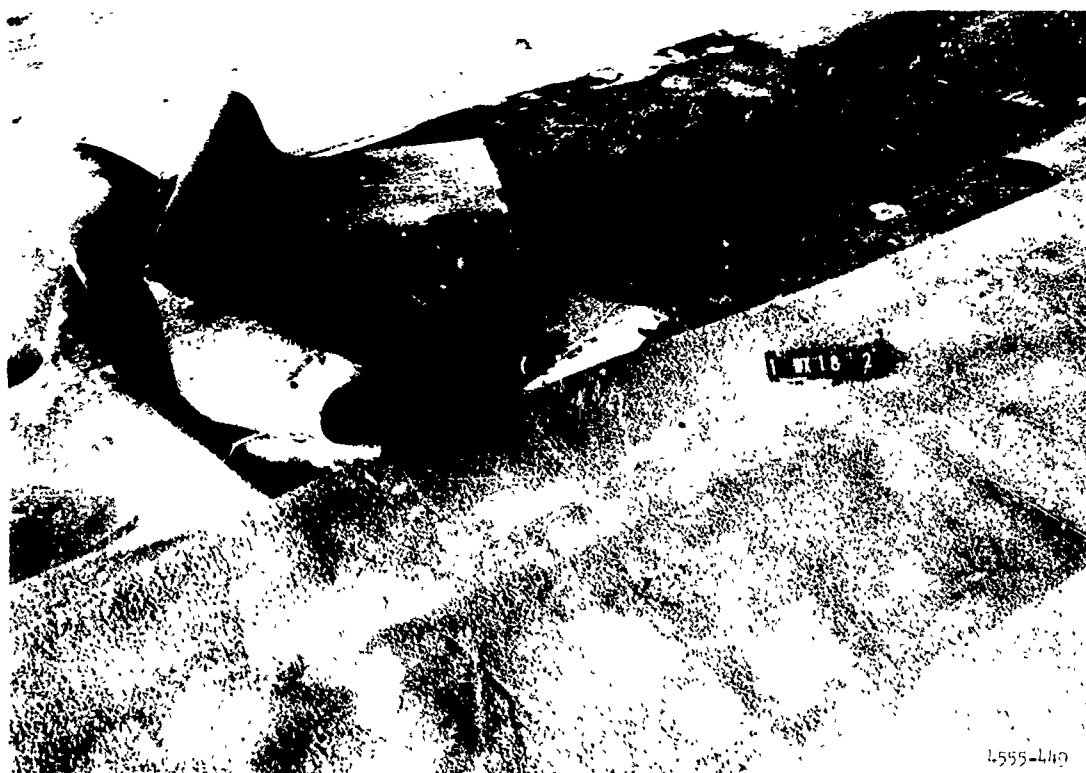
Photograph 46. First-ply failure after the twelfth skid on run 1 of WX18 membrane surfacing

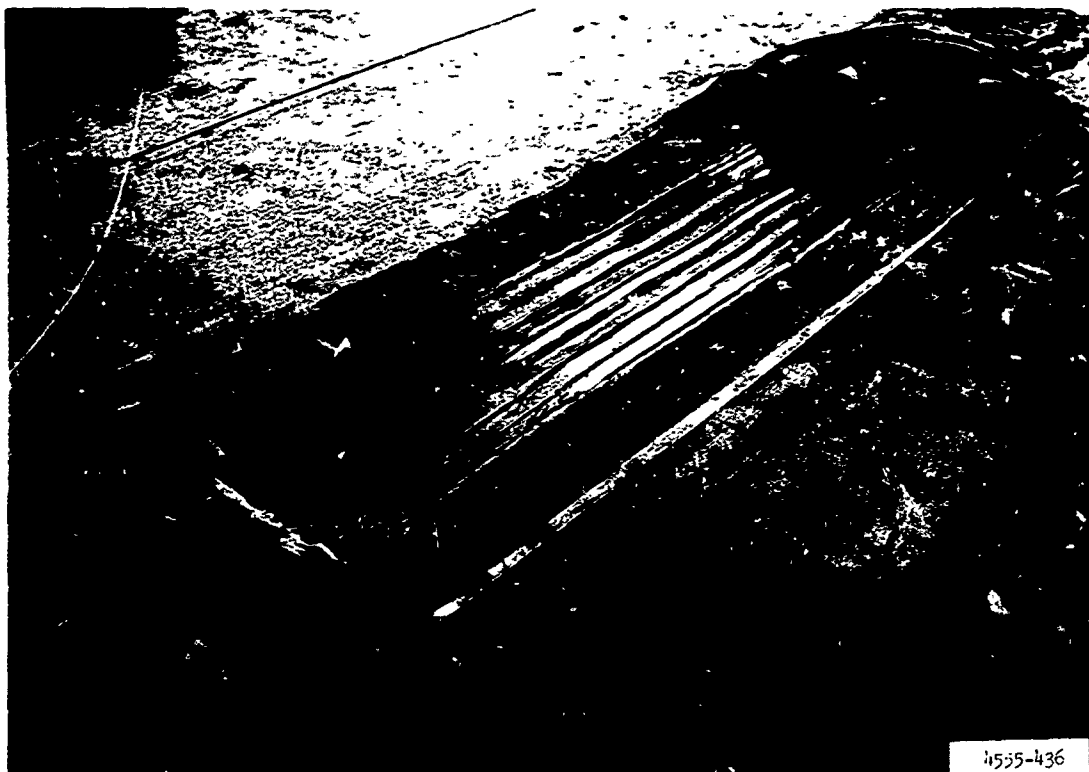
Photograph 61. Failure after the twelfth skid on run 2 of XW23 experimental membrane surfacing

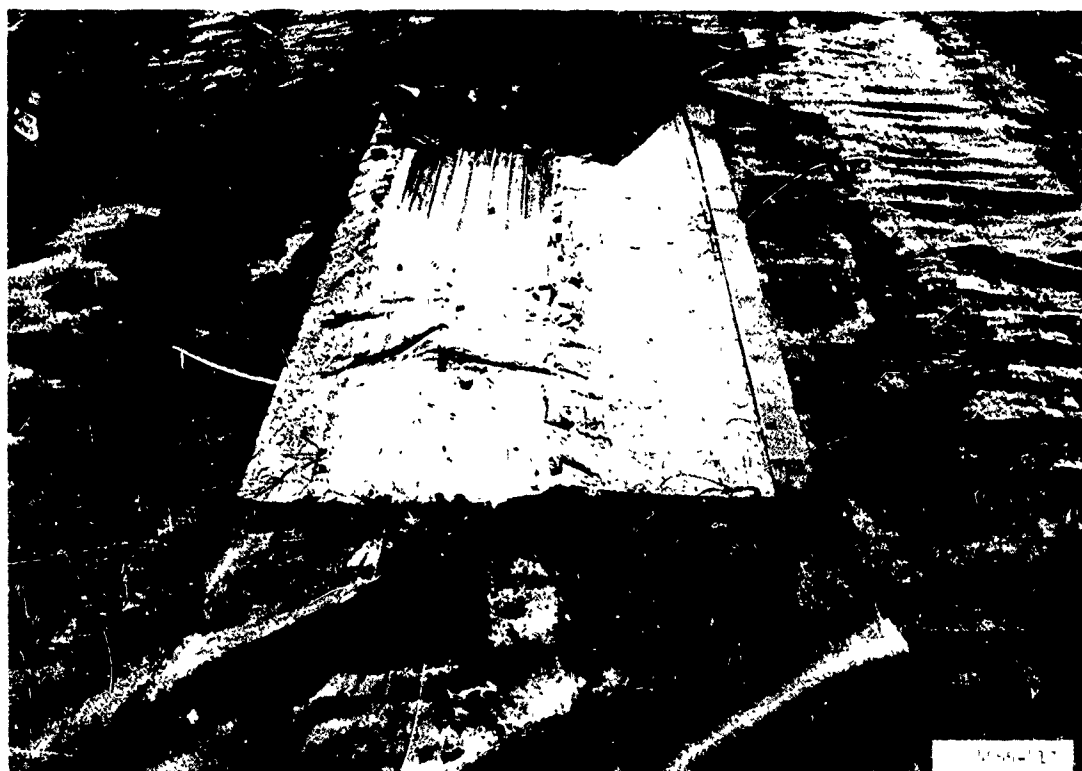
Photograph 75. First-ply failure after ninth skid on run 2 of XW26 experimental membrane surfacing

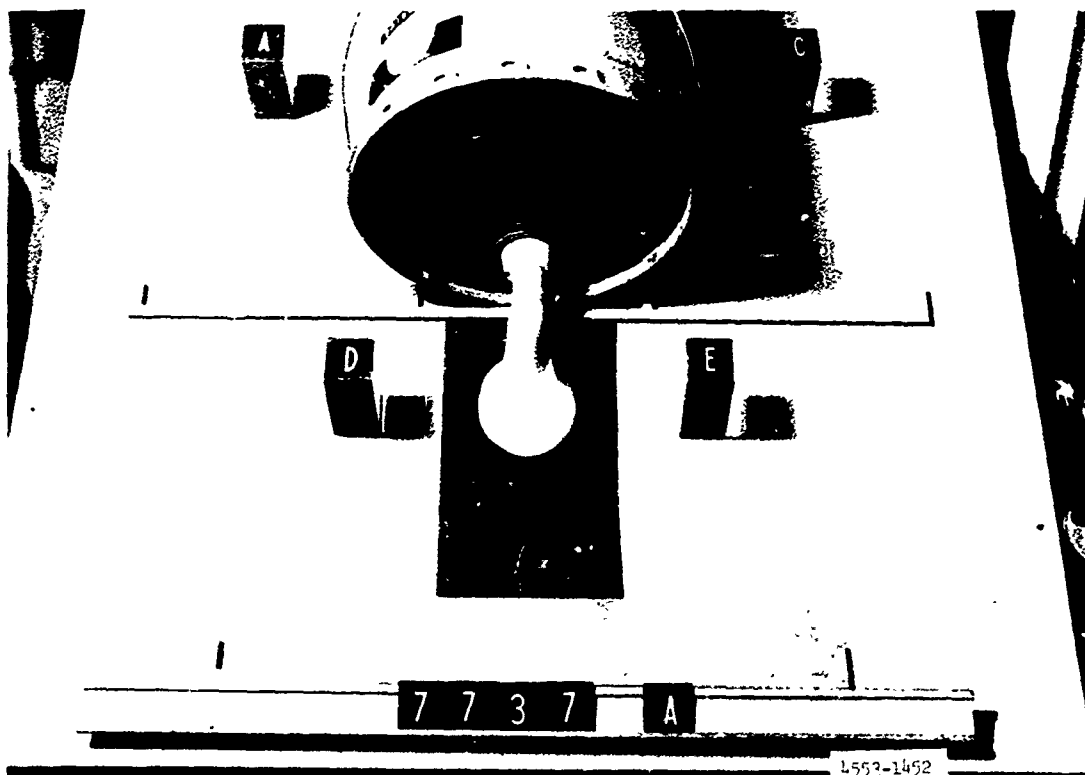
Photograph 85. Failure after ninth skid on run 2a of XW26 experimental membrane surfacing
